# **WATERWAY AND CATCHMENT REPORT**

Reporting on data November 2021 to April 2022

MidCoast Council 2022 Waterway and Catchment Report  
Prepared by:  
MidCoast Council  
Natural Systems

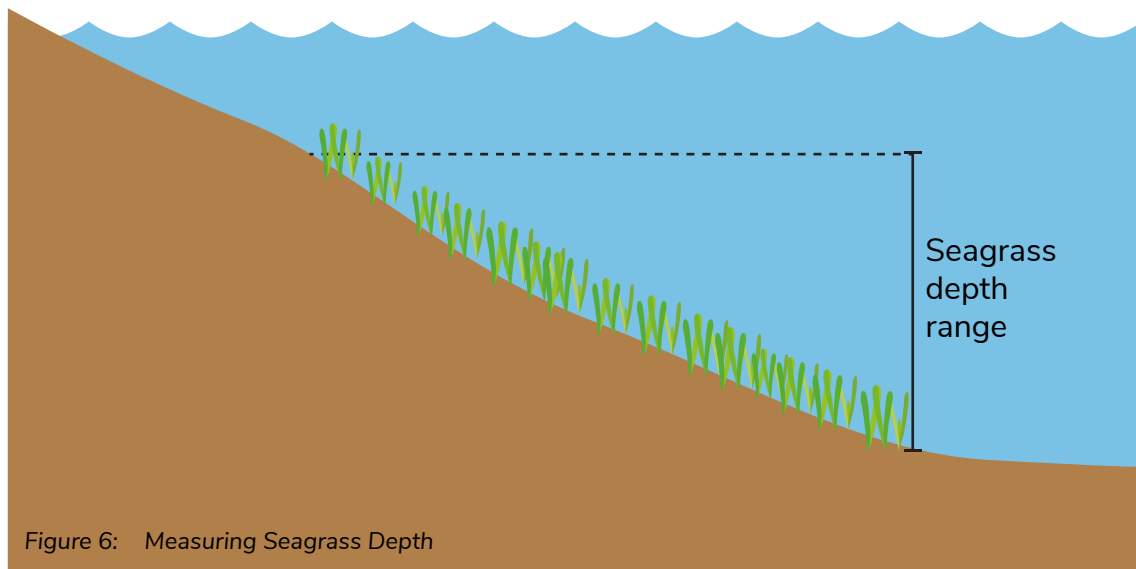
Figure 6: Measuring Seagrass Depth

A report card grade is calculated following the analysis method outlined in the New South Wales sampling and reporting protocols (OEH, 2016). Briefly, the seagrass depth range scores are based on not only the recorded depth range for a specific year, but also how that compares to the previous year, meaning how seagrass has progressed, recovered or regressed over time since the previous survey. The seagrass score is presented separately in the report card and does not affect the overall ecological health grade.

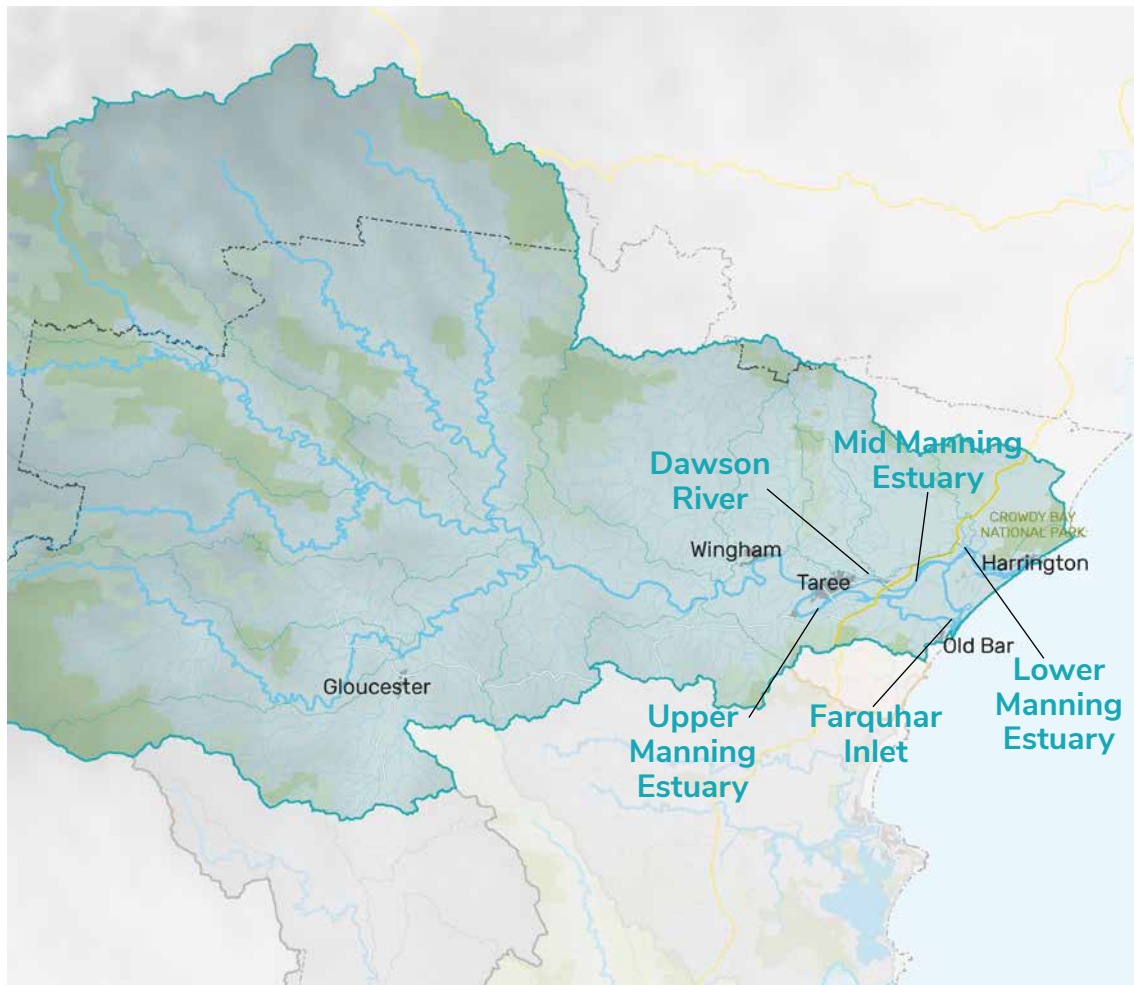
Figure 13: Manning River

The Manning River has a catchment area of 8,420 square kilometers, which makes it the sixth largest on the coast of NSW. The Manning River is unique on the NSW coast because it is a double delta with two river entrances at Harrington and Old Bar. The main land uses within the catchment are urban development, beef cattle grazing, dairying, oyster growing and forestry. Significant areas of the catchment are also conserved within National Parks and Nature Reserves. The majority of the catchment's population live in the estuarine zone around the town centres of Taree, Wingham, Cundletown, Harrington and Old Bar.

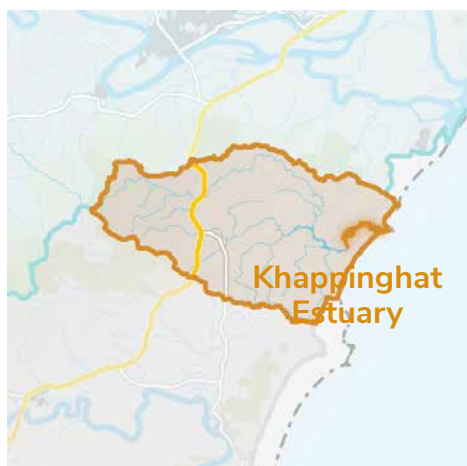
The Khappinghat improved in its ecological health from fair to good this year, due to a decrease in algal growth compared to last year. The water clarity grade remained the same and the average salinity was similar to last year. The lower algal growth is likely due to less nutrients entering the estuary as the catchment recovers from the extensive fires in 2019-2020.

Salinity was generally within the brackish range typical of intermittently open/closed lagoons when sampling occurred. Turbidity exceeded guideline values in less than half the samples. We expect little exceedance of guideline values given that the estuary is surrounded by a national park. The highest exceedance was at the upstream site when the salinity was 5psu, or 15% as salty as the ocean, reflecting a larger influence of runoff from the catchment following February storms.

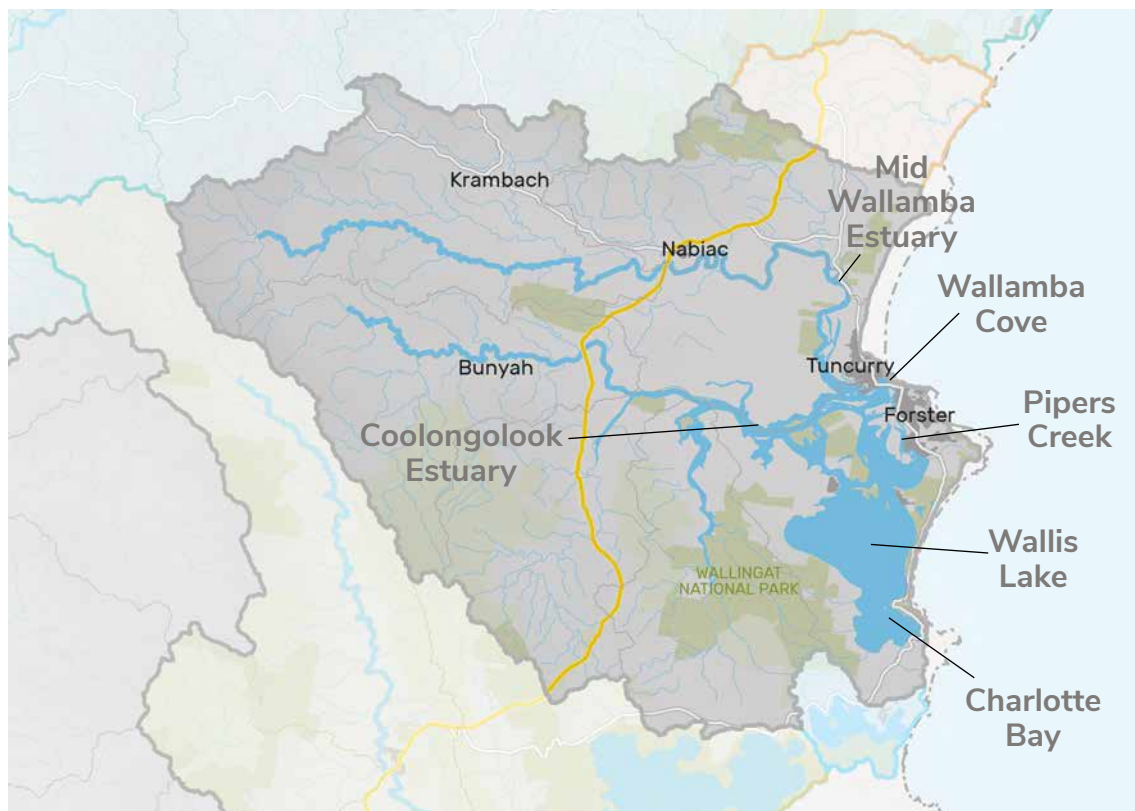
Figure 14: Wallis Lake

Wallis Lake is one of the most significant producers of Sydney Rock Oysters in Australia and is also central to the local tourism industry, valued at over \$315m per year. The lake is one of New South Wales' top three producing estuarine fisheries, it produces 80% of the states commercial crabs and is utilised extensively for recreation including boating, fishing and swimming.

The Wallis Lake catchment contains habitat for threatened and international migratory species and contains 35% of the seagrass beds of New South Wales, as well as the second largest representation of saltmarsh in the State.

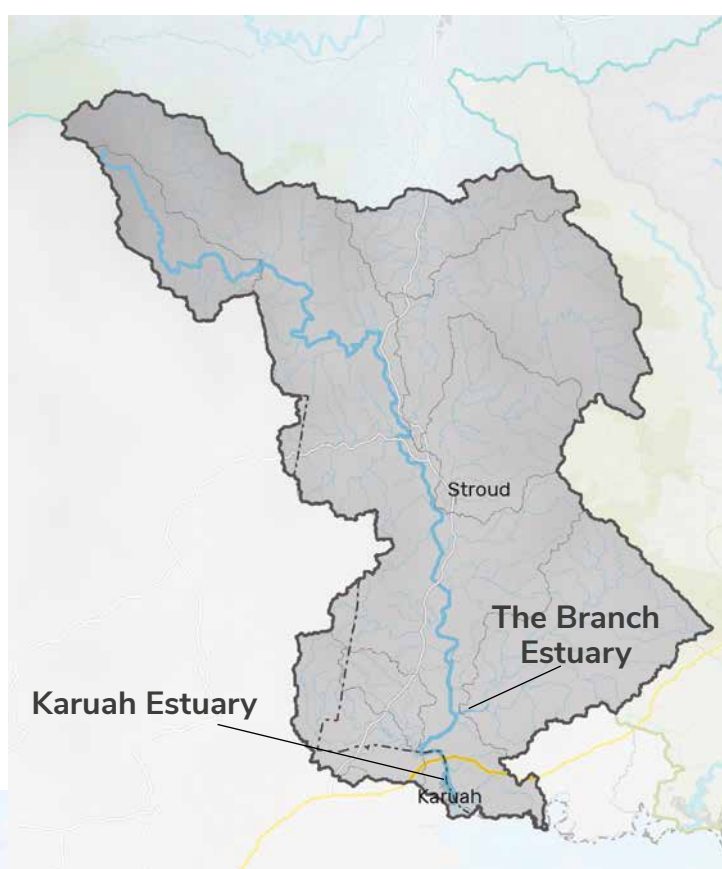
Figure 17: Karuah River Catchment.

The Branch is a subcatchment of the wider Karuah River Catchment and is approximately 211 square kilometres. The Branch subcatchment is a mosaic of floodplain environments, with steep ridgelines traversing from the upper catchment through to the tidal zone of the river. The subcatchment is sparsely populated, without any settlements. Landuse is primarily grazing land with some forest and woodland in the upper catchment.

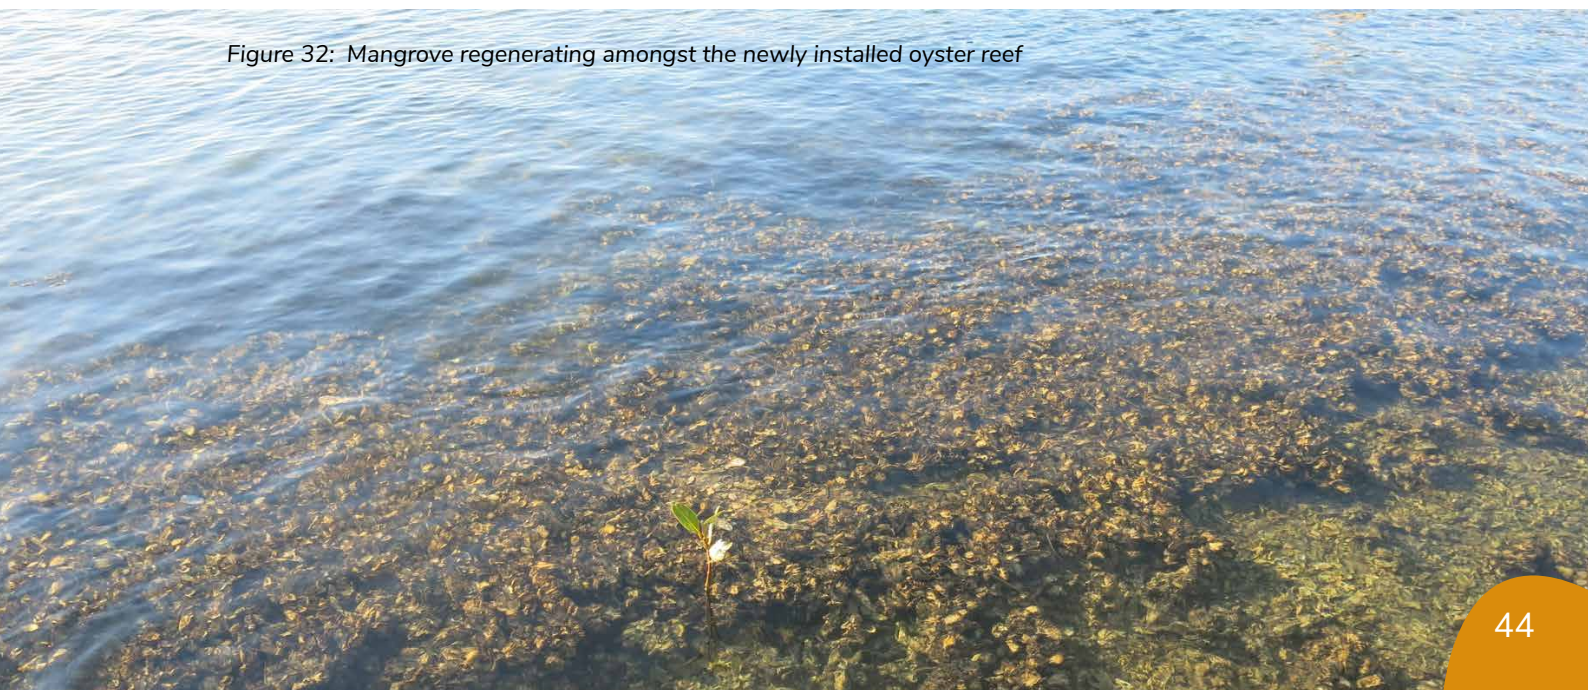
Figure 32: Mangrove regenerating amongst the newly installed oyster reef

Restoration models were created utilising the data from the surveys to look at areas where habitat restoration would be most beneficial as well as to prioritise works in the Wallis Lake system. This information will be utilised by MidCoast Council and Local Land Services to plan and implement management actions and create the best environmental outcomes for our local estuaries.

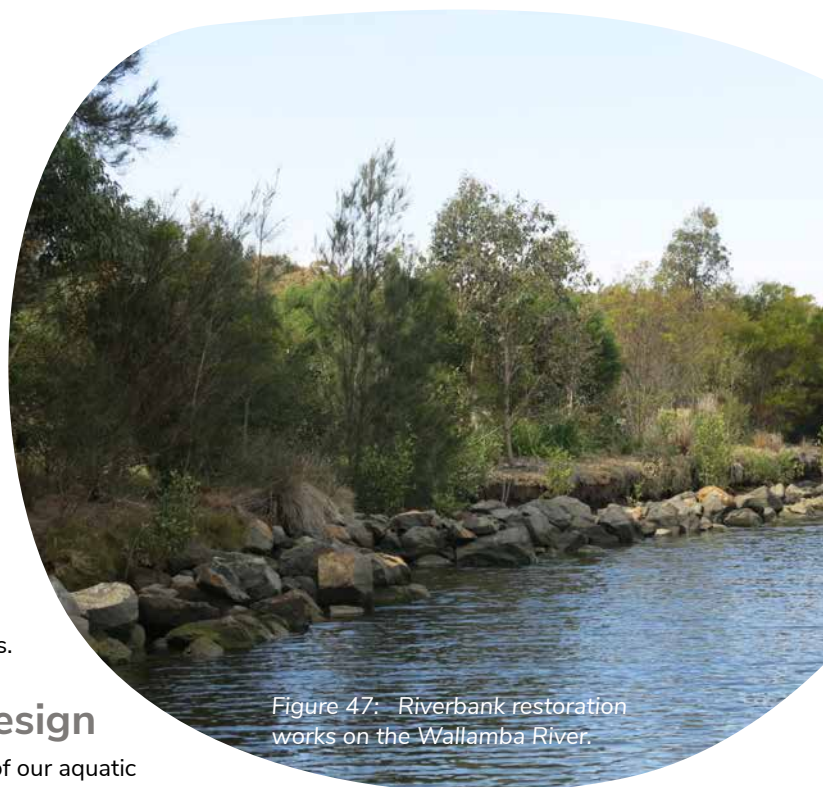
Figure 47: Riverbank restoration works on the Wallamba River.

MidCoast Council have continued to partner with Local Land Services to implement actions to improve water quality and fish habitat in the lower Wallamba River. New areas of oyster shell and hardwood timber restoration works have continued, protecting the riverbanks from erosion. This year, works have been hampered significantly by the continual wet weather impacting on access to sites.

The restoration works have been focussed on Gereeba Island in the Wallamba River and Council are partnering with the oyster industry to use discarded shell from their production process. Works have utilised a combination of logs, oysters and mangroves to stabilise eroding foreshore areas.

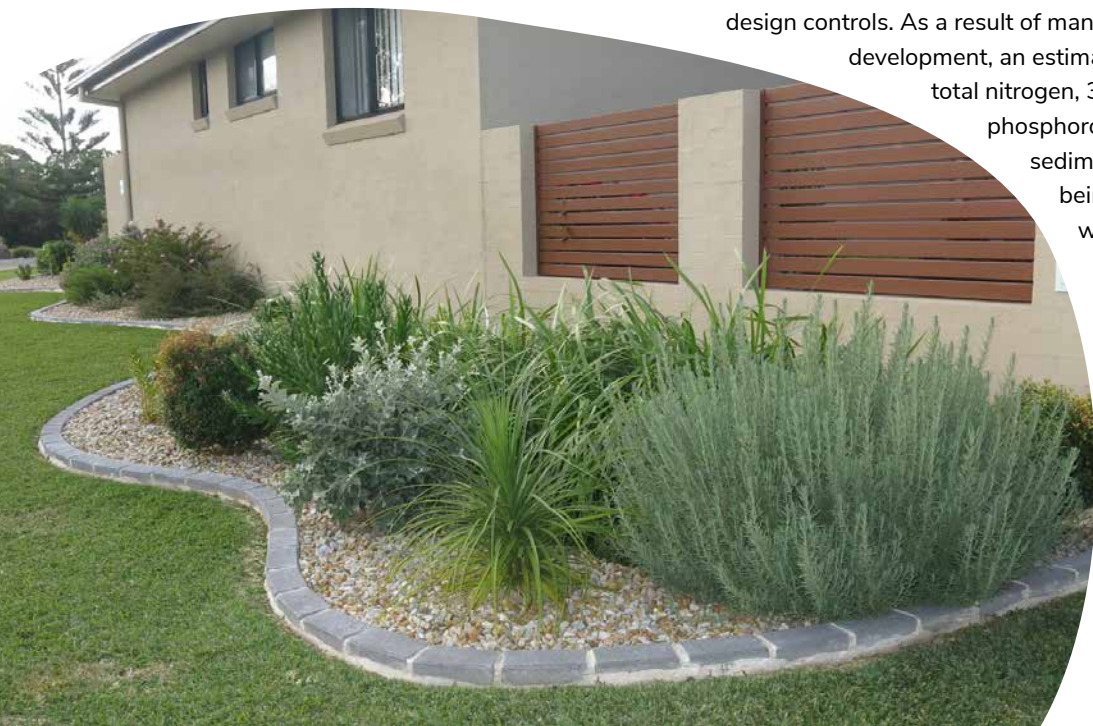
Figure 48: Applying water sensitive urban design to new development

Small scale, infill developments, such as single dwellings located in the southern region, must include water sensitive design controls that protect our sensitive lake systems from nutrients and sediments.

Since 2015, 947 new houses were required to include water sensitive design controls. As a result of managing the impacts of development, an estimated 304 kilograms of total nitrogen, 33 kilograms of total phosphorous and 15 tonnes of sediment is prevented from being washed into our waterways each year.

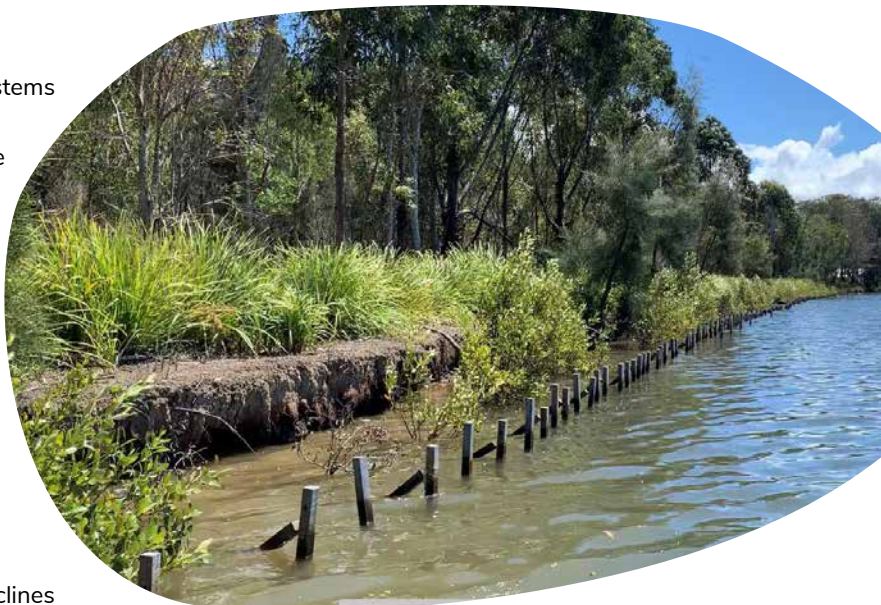
Figure 49: Restored Oyster Reef on the Wallamba River.

Shellfish or oyster reefs occur naturally in estuaries and they create important habitat for fish and other species, they can also help prevent erosion. Wallis Lake and Manning River estuaries are systems where declines in shellfish reef extent and condition have previously been documented. These declines in reef extent and condition have been implicated as contributing towards fisheries declines and oyster reef restoration has been identified as an important part of estuarine management not only in MidCoast systems but throughout NSW.

Utilising the data from the surveys restoration models were created to look at areas where habitat restoration would be most beneficial as well as to prioritise works in the Wallis Lake system. This information will be utilised by MidCoast Council and Local Land Services to plan and implement management actions and create the best environmental outcomes for our local estuaries.
