**MANNING
RIVER
ESTUARY &
CATCHMENT**

SPATIAL RISK ASSESSMENT 2020

Swanson, R. (2019). Manning River Estuary and Catchment RISK ASSESSMENT. An assessment of risk of catchment pressures on ecological and community values of the estuary. Environment, Energy and Science. NSW Government, Sydney.

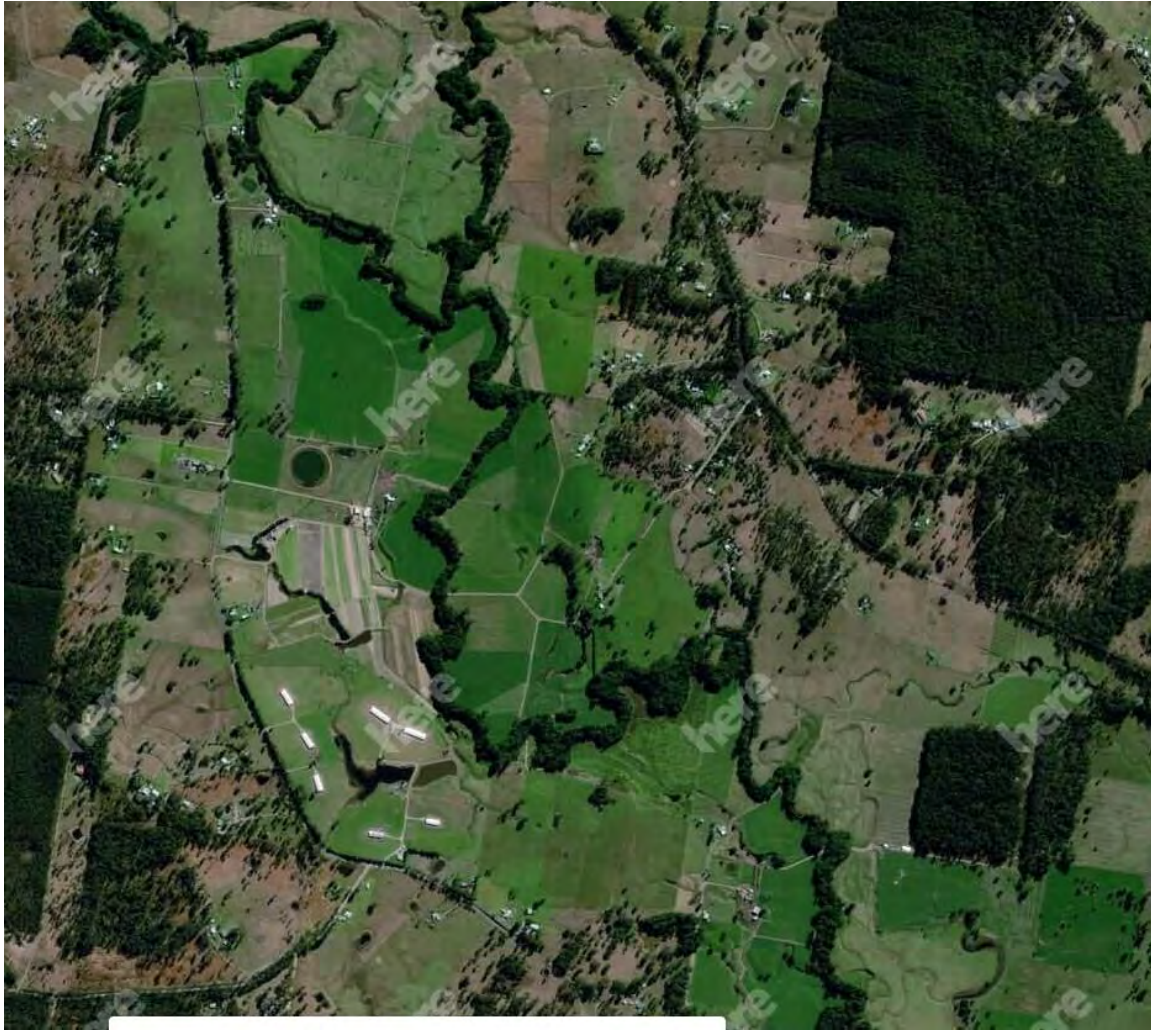
Photograph 1 Google Earth image of Upper Lansdowne showing high fertilisation pastures, Banksia Turf Farm and a large poultry farm (white sheds) adjacent to Lansdowne River (Google Earth). A Rapid Site Assessment (88-10) of the river adjacent to turf farm showed scum layer on surface of large isolated pools suggestive of algal blooms (Swanson 2019)

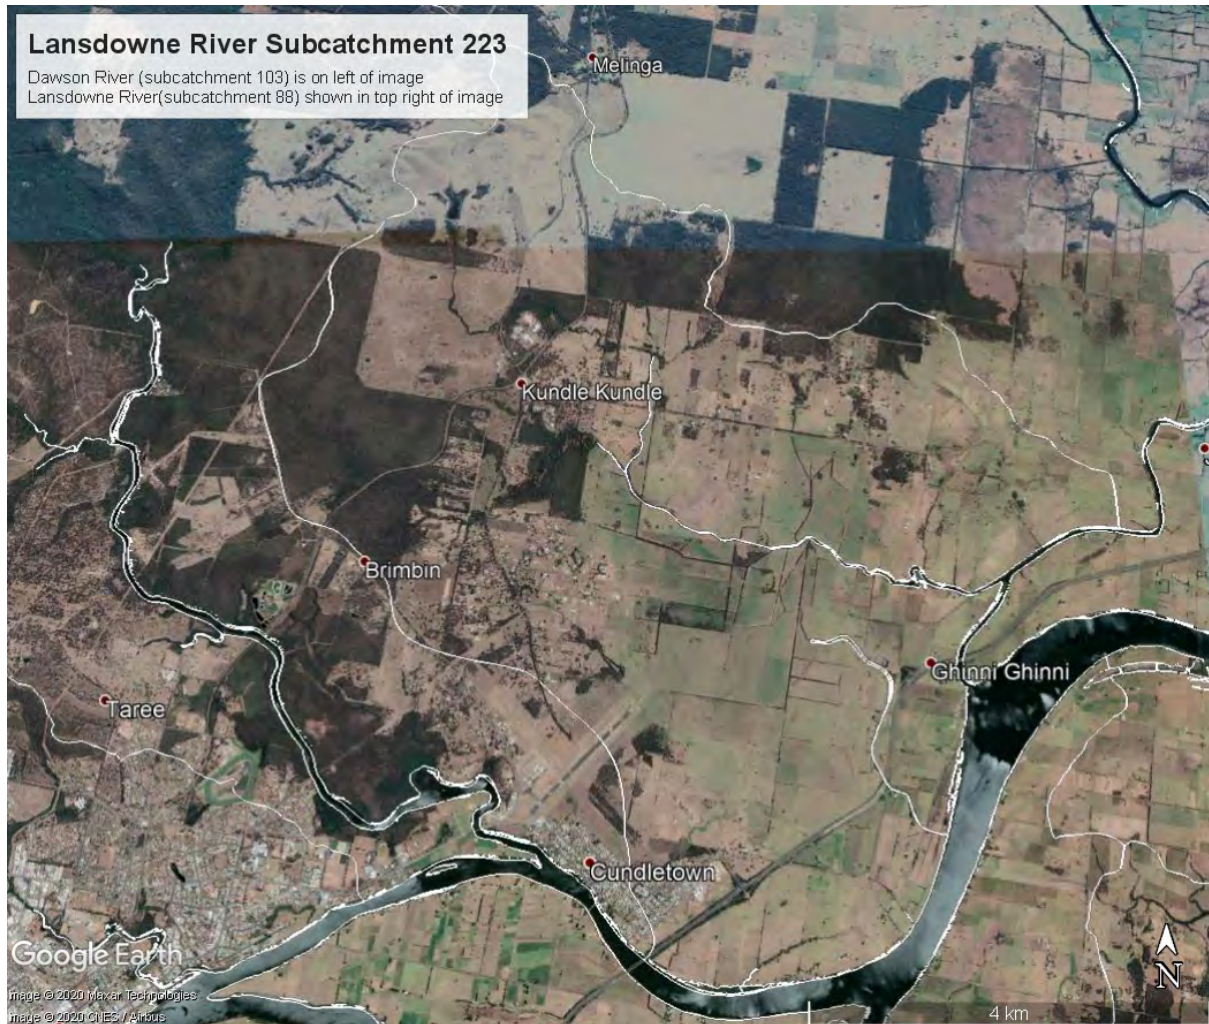
Photograph 2 Lansdowne River subcatchment 223 (Ghinni Ghinni Creek) showing towns of Kundle Kundle and Cundletown, and the dominant land use - grazing modified pastures. The image reveals the impact of the extended drought on the catchment on December 3, 2019 (Google Earth)

Subcatchment 223 lies to the south-west of subcatchment 88 and is situated on the estuary adjacent to Jones Island. Ghinni Ghinni Creek connects the estuary to Lansdowne River. Subcatchment 223 includes the rural townships of Cundletown and Kundle Kundle (Photograph 2). Land use for subcatchment 223 is shown in Map 5. Approximately half of the subcatchment is Grazing Modified Pastures (3.2.0) and one-third of these pastures were deemed to have high level of fertiliser use (Map 5, blue highlight, 18% of total subcatchment). Grazing Native Vegetation comprises 9% of the subcatchment (2.1.0) and only 12% is forest (1.3.3. Residual Native Cover, Map 5).

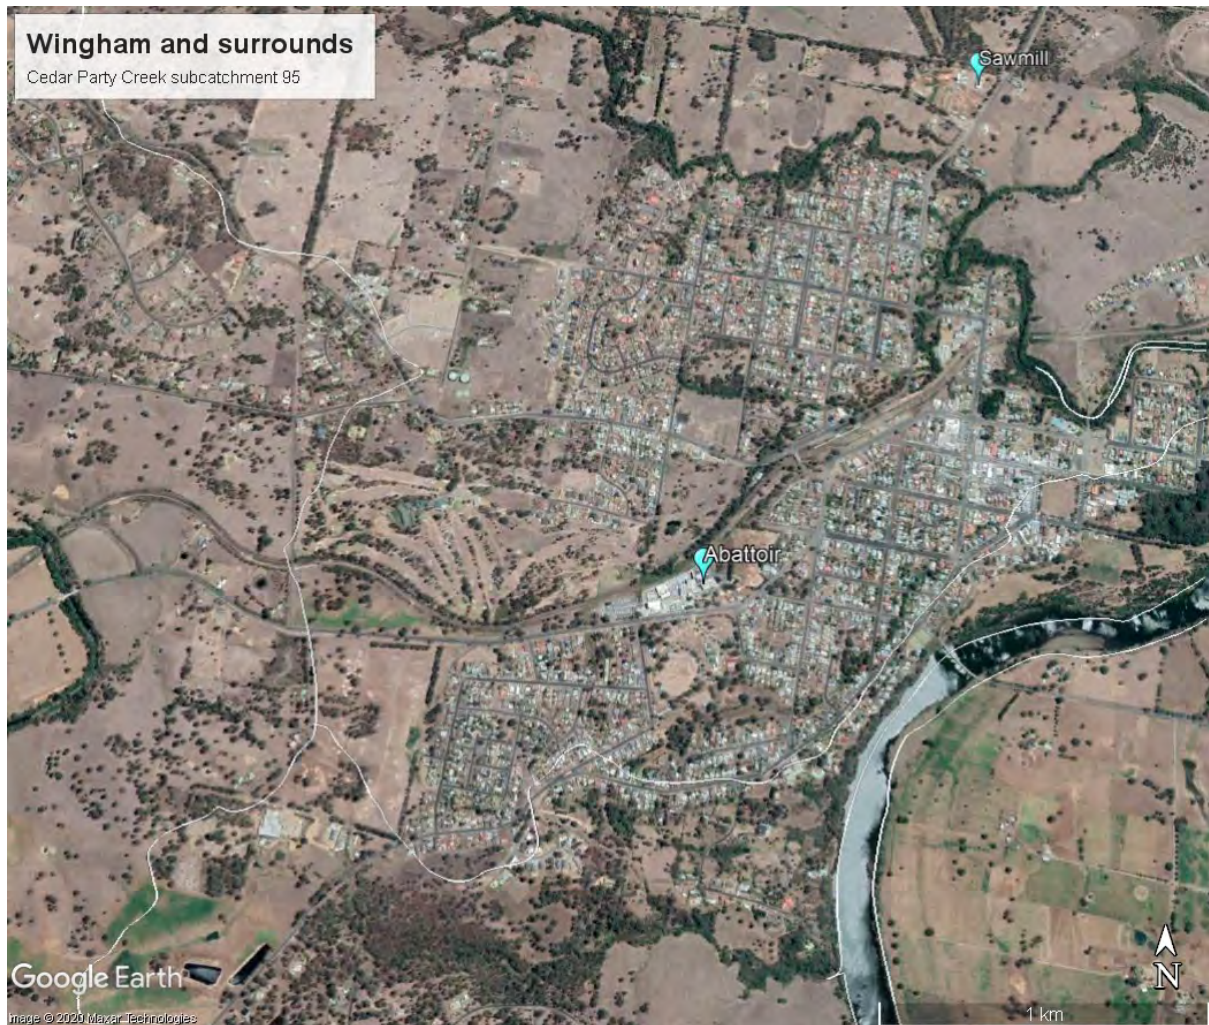
Photograph 3 The township of Wingham, located at the southern end of Cedar Party Creek - subcatchment 95. Sawmill and abattoir are marked on map. The image from December 3, 2019 reveals the impact of the extended drought on the catchment (Google Earth)

Subcatchment 95 is farther upstream with a direct connection to the estuary, east of Wingham. Subcatchment 95 includes rural townships Wingham, Cedar Party, Strathcedar and Killabakh. Land use is shown in Map 6 with one-third of subcatchment designated as Grazing Modified Pasture (GMP 3.2.0) and only 3% of GMP use a high level of fertiliser. One-third of land use is Grazing Native Vegetation (2.1.0) and only 15 % of the subcatchment is forest (1.3.3. Residual Native Cover). A variety of intensive land use occurs in the subcatchment including poultry farms, an abattoir and a sawmill (Map 6, Photograph 3). The abattoir in Wingham has high stocking densities and use effluent to fertilise their pastures. Some community members have linked a decline in water quality to land application of effluent at the abattoir.

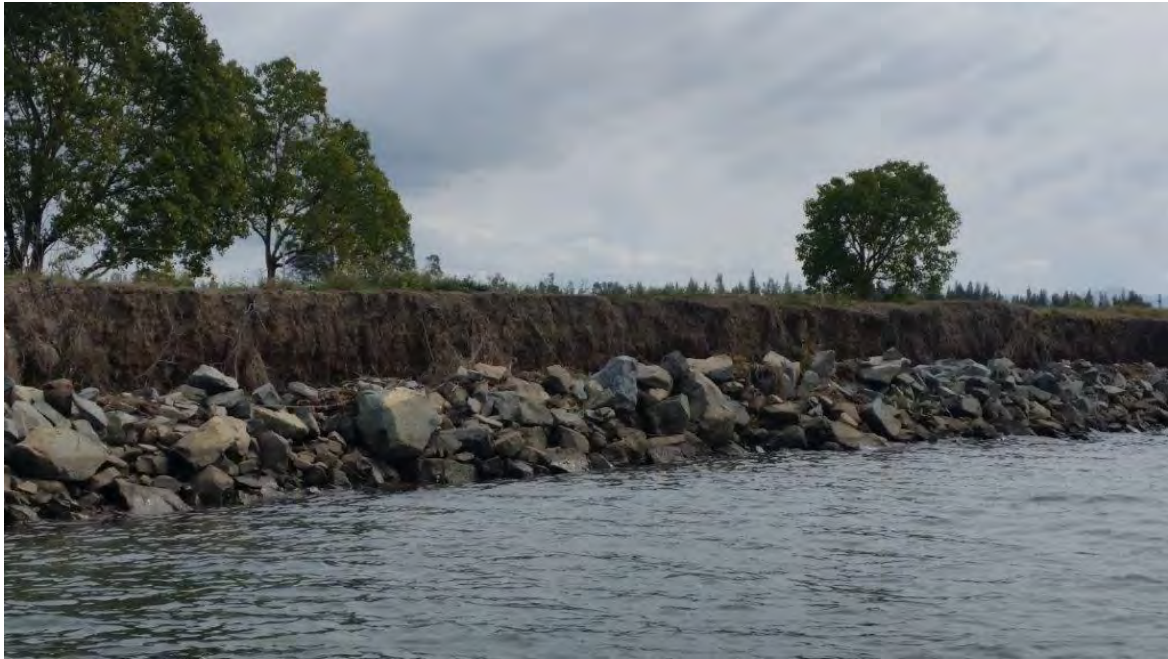
Photograph 4 Rock revetment and fencing on Jones Island (205) to protect bank from further erosion

Bank erosion is widespread along the main estuary channels and was recorded and photographed in the ground-truthing program (Swanson 2019). Bank stabilisation has occurred in some areas with fencing to restrict cattle access. Rock revetments have been constructed in areas with severe erosion to prevent further erosion (Subcatchments 205, 207; Photograph 4).

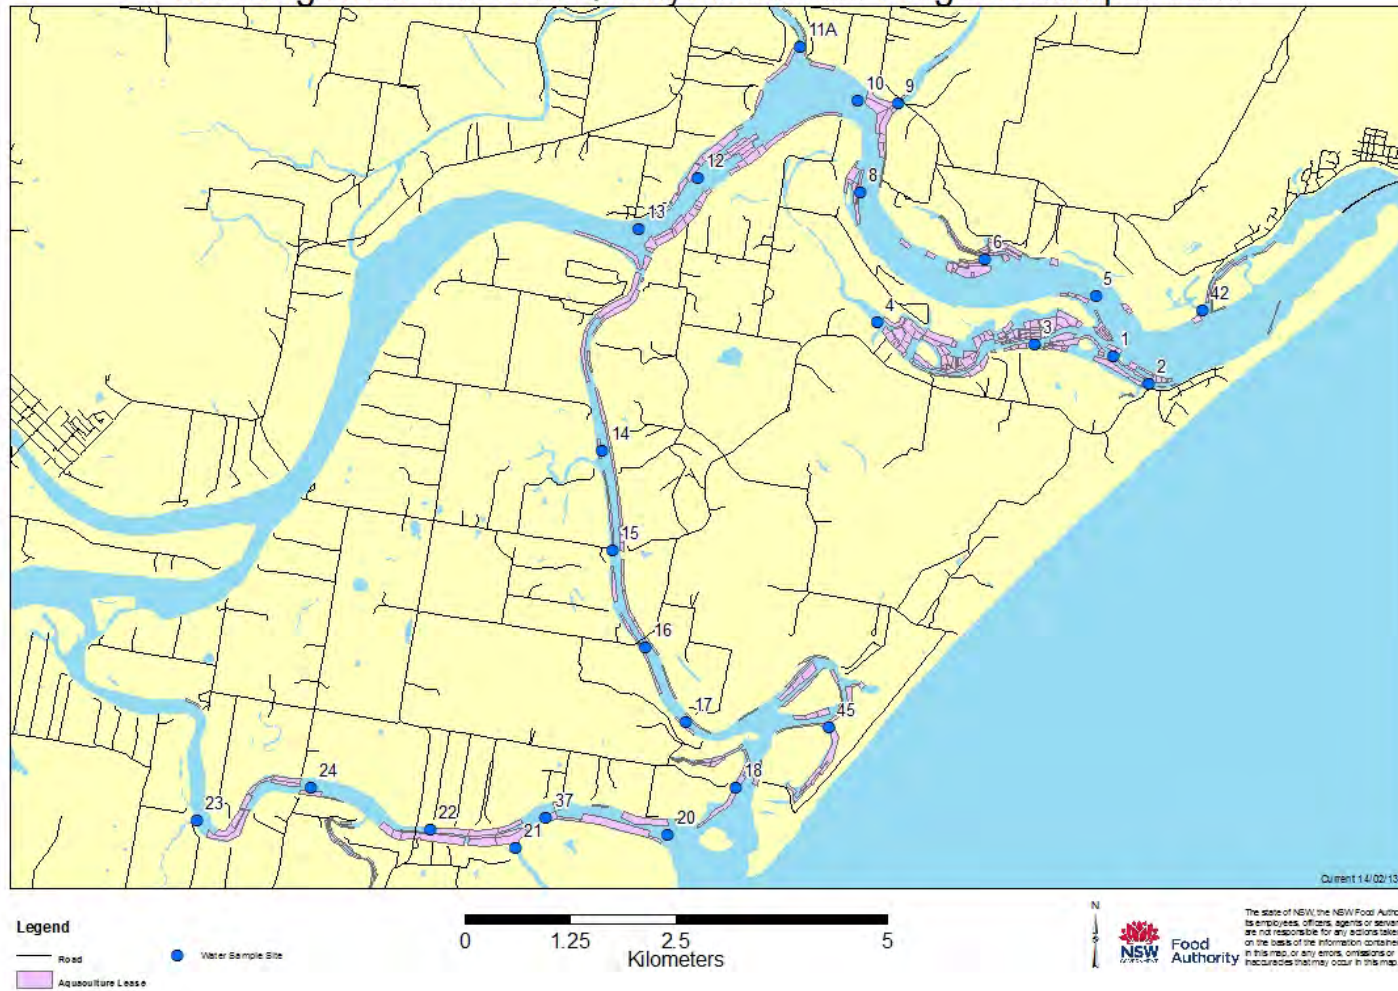
Map A3 - 16 Locations of water quality monitoring by NSW Food Authority as part of the Manning River Shellfish Quality Assurance Program (total faecal coliform data shown in Table A3-3)

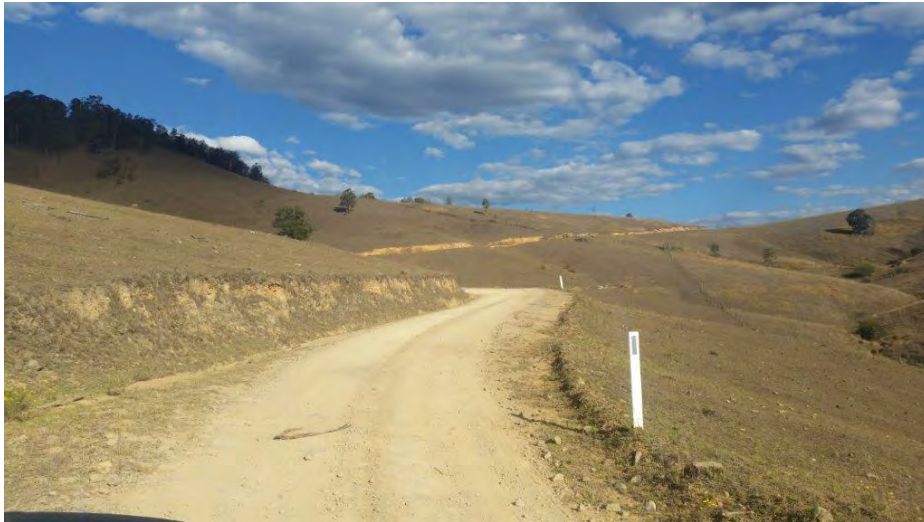
Photograph A4-1 Subcatchment 74 – Cells Rd, steep bare hills pose a high erosion risk

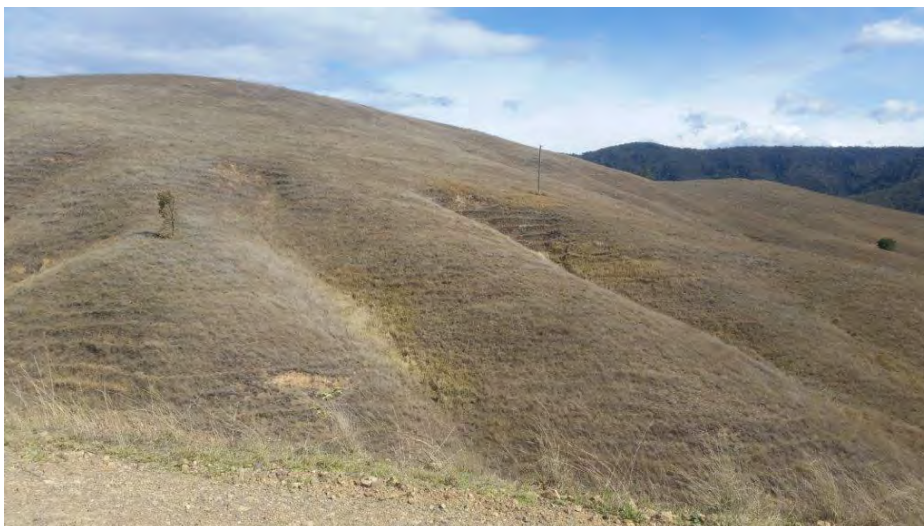
Photograph A4-2 Active erosion in subcatchment 85

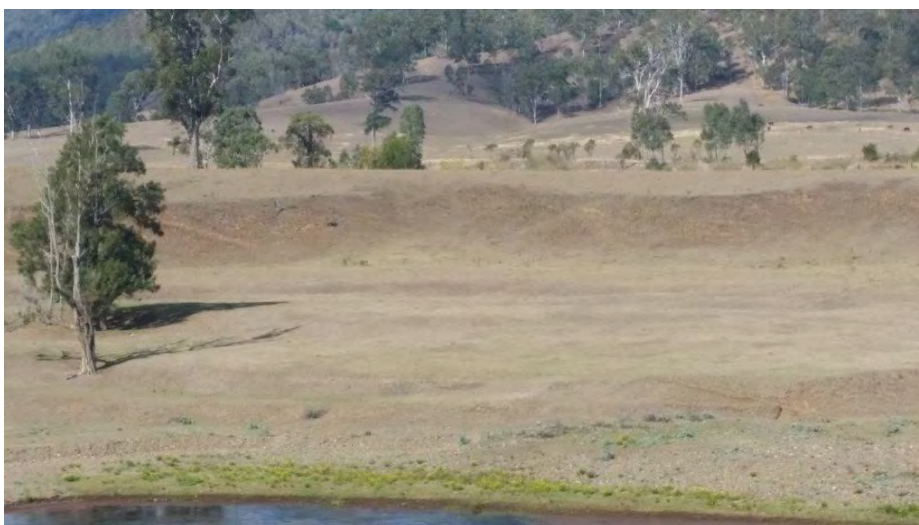
Photograph A4-3 Hillslope erosion, erosion gullies and no riparian vegetation (subcatchment 105)

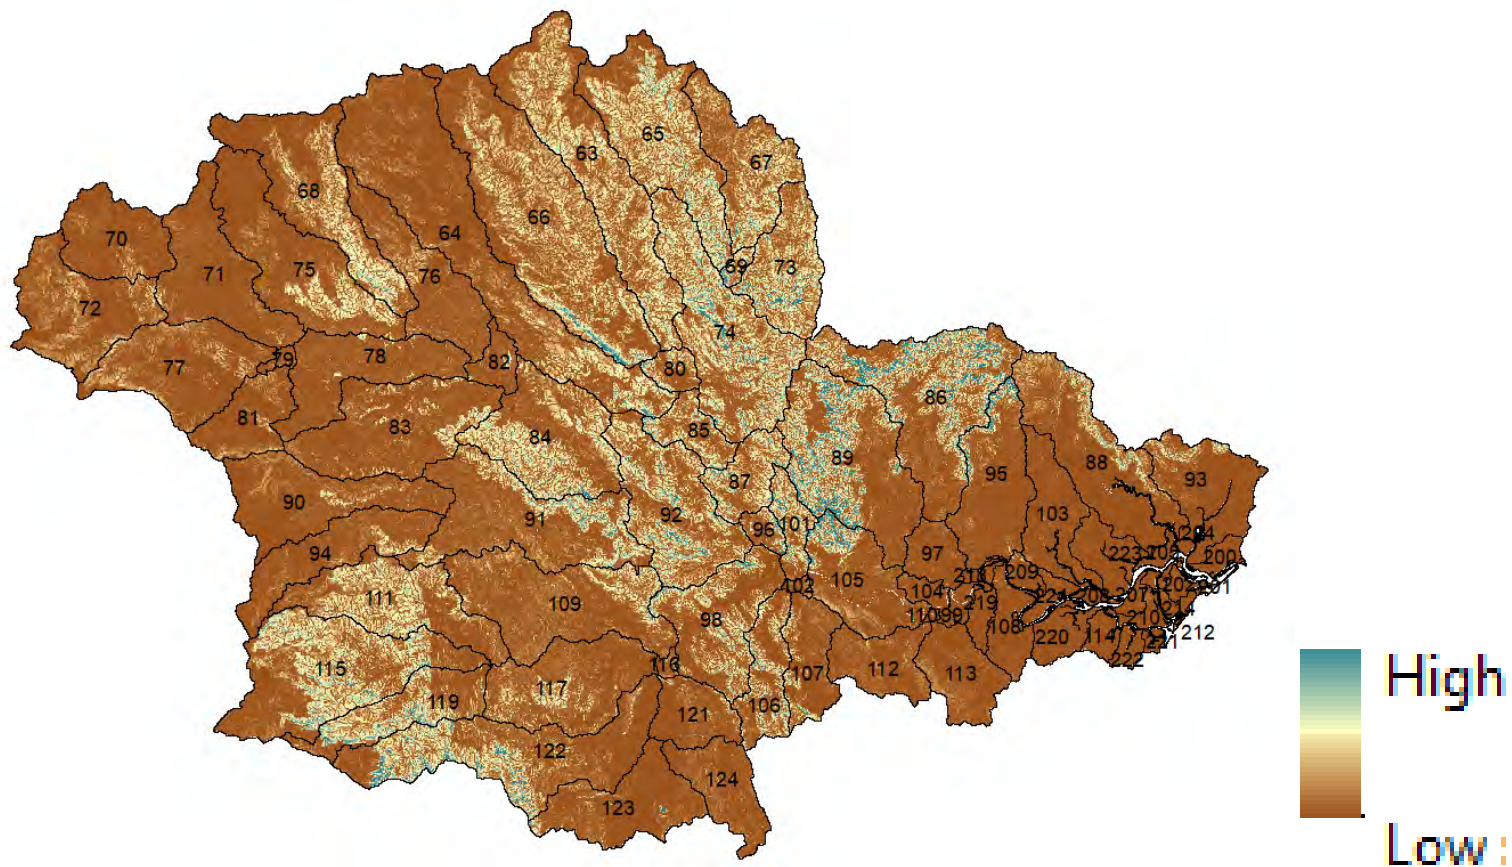
Map A4 - 1 Modelled hillslope erosion in the Manning River catchment (Yang 2019). Likelihood Scores for hillslope erosion were generated from total erosion data for each subcatchment
