Proposed Forster Civic Precinct Project
Cnr Lake, West and Middle Street, Forster

Geotechnical Assessment

Report No. RGS01471.1-AB

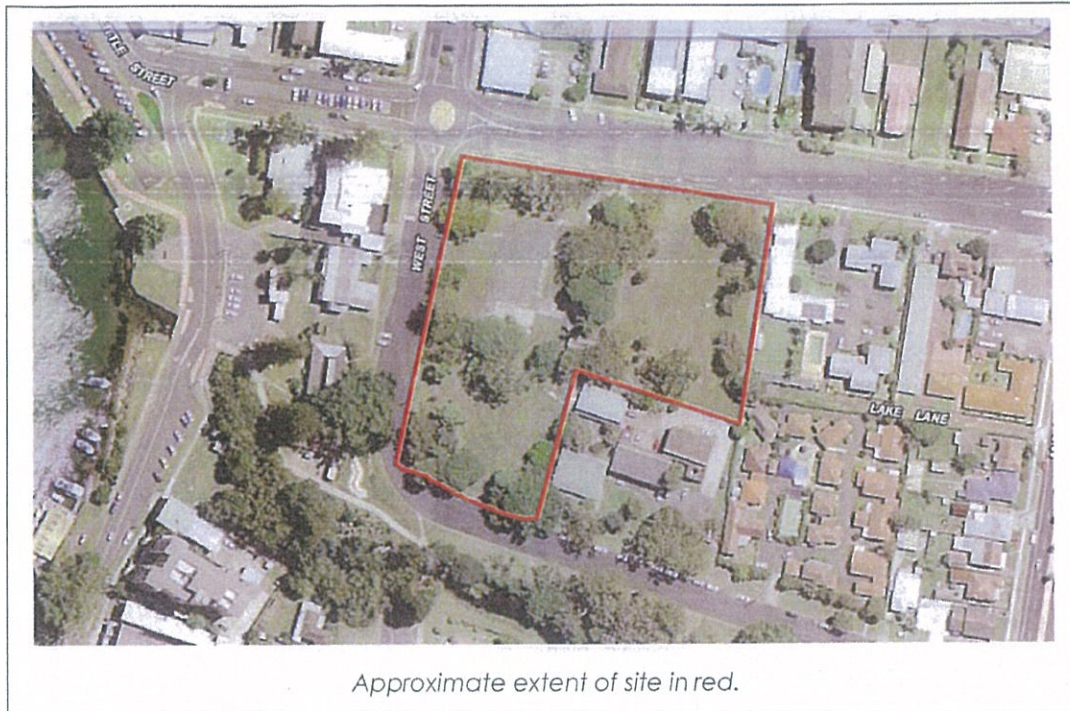
An image of the site taken from the NSW Department of Property Information website is reproduced below.

The site is bound by residential houses to the east and south east, Lake Street to north, West Street to the west and Middle Street to the south. Currently the site is vacant except for some paved areas on the north-western portion of the site. Several large trees were present across the site. Previously the site was occupied by a school and associated buildings such as toilet blocks. A small house was observed approximately in the middle of the site.

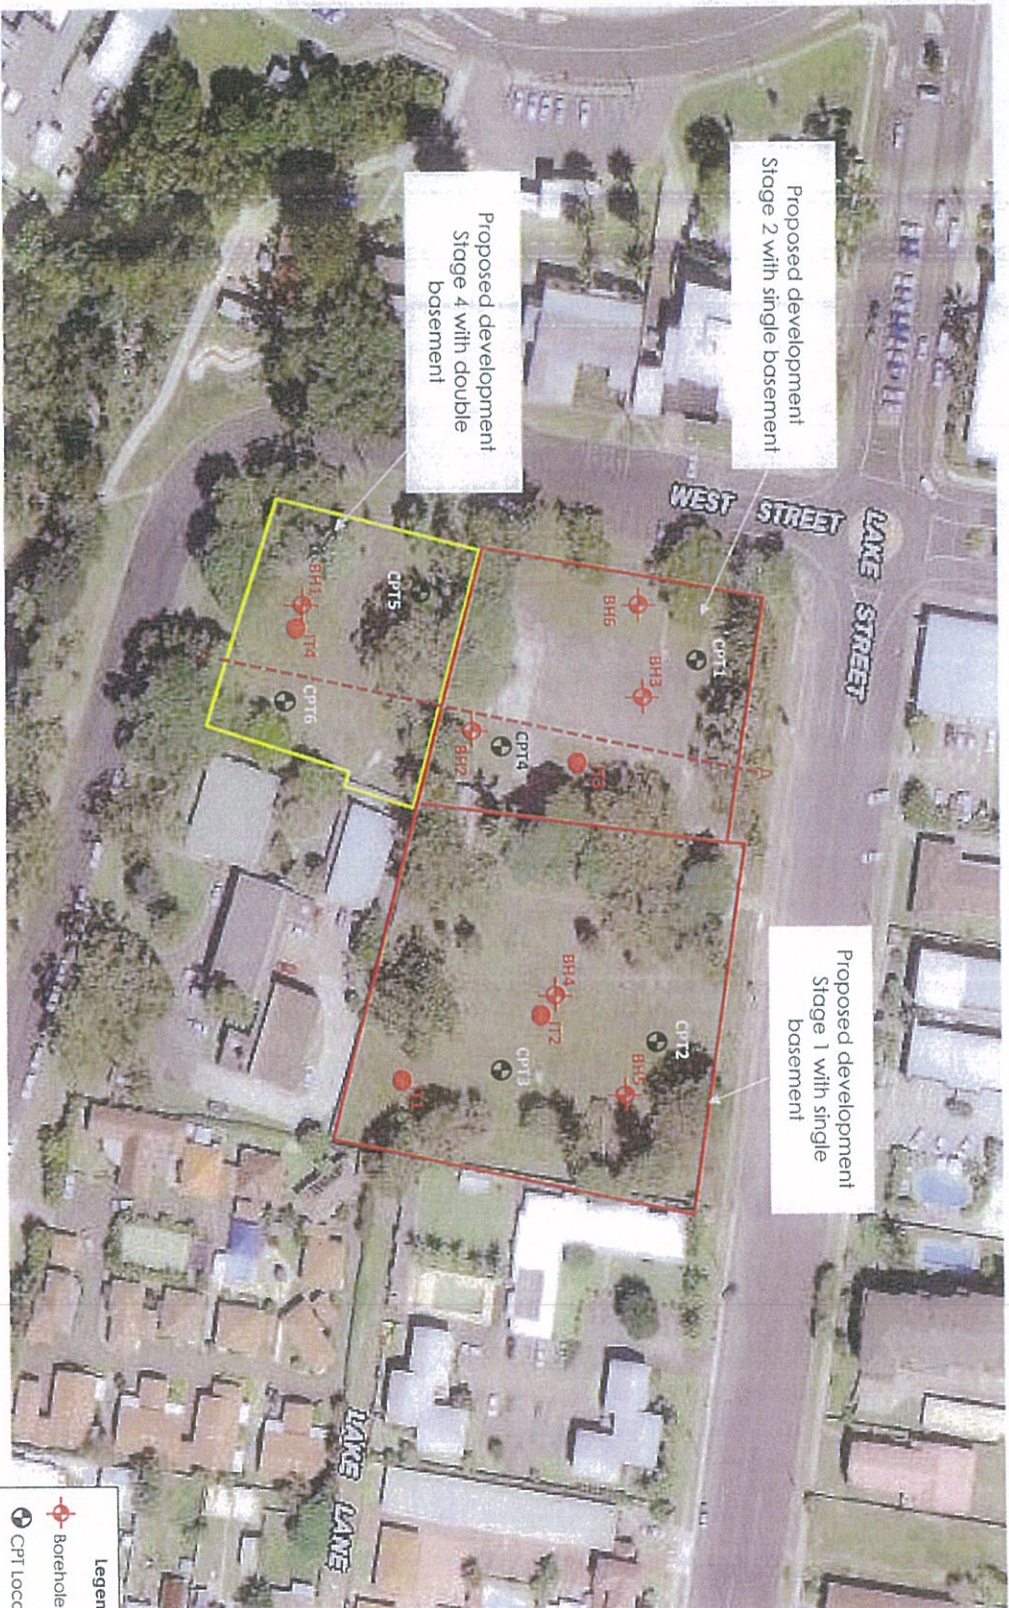
Client	Kukas Brothers		Job No.	RG501471.1
Project:	Forster Civic Precinct Project		Drawn By:	CN
Title:	Cnr Lake, West and Middle Street, Forster		Date:	30-Jan-17
	Investigation Location Plan		Drawing No.	Figure 1

Engineering logs of the boreholes, CPT results, and infiltration test results are presented in Appendix A. The locations of the boreholes, infiltration tests and CPT are shown on Figure 1. They were obtained on site by measurement relative to existing site features.

Test number:	IT1	Test Location:	Refer to Figure 1
Hole radius (m):	0.042	Surface RL:	Not measured
Hole depth(m):	0.50	Casing stickup(m):	1.30
Depth to water table (m):		Water table RL(m)	Unknown

Test number:	IT2	Test Location:	Refer to Figure 1
Hole radius (m):	0.042	Surface RL:	Not measured
Hole depth(m):	0.65	Casing stickup(m):	1.30
Depth to water table (m):		Water table RL(m)	Unknown

Test number:	IT3	Test Location:	Refer to Figure 1
Hole radius (m):	0.042	Surface RL:	Not measured
Hole depth(m):	0.70	Casing stickup(m):	1.30
Depth to water table (m):		Water table RL(m)	Unknown
