MIDCOAST
council

WATERWAY AND CATCHMENT REPORT CARD

Reporting on data October
2017 to March 2018

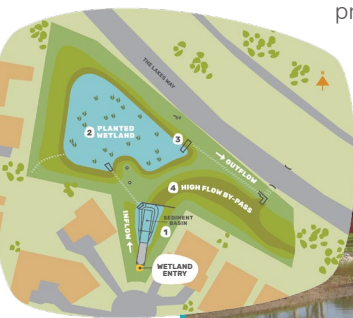
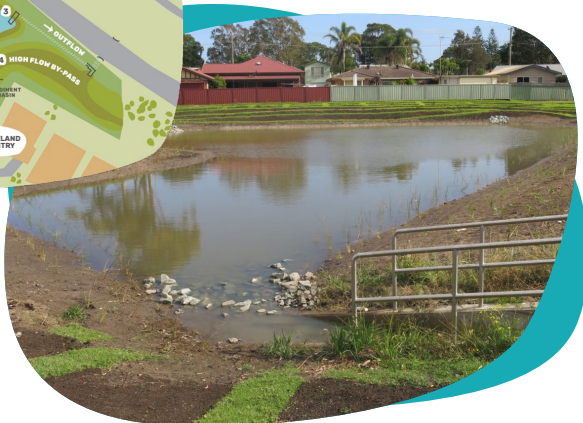
ARLINGTON WETLAND

Wallis Lake is heavily impacted by pollutants in stormwater runoff from the adjacent urban land. To improve water quality entering the lake a constructed wetland treating water from 7.1 hectares of land has been installed in south Forster.

The wetland is designed to remove sediment and filter nutrients before the water is discharged into the lake. The project is one of many water quality initiatives that are happening within our community to improve the health of Wallis Lake.

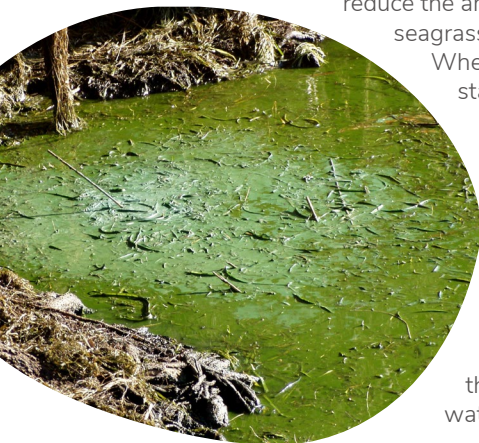
Algae are microscopic plants that can grow excessively with high levels of nutrient inputs. Nutrients are delivered to estuaries from urban stormwater, fertiliser and sediment runoff from farms and gardens and seepage from effluent disposal and septic tanks. Algal blooms can reduce the amount of light reaching

seagrass beds limiting their growth.

When algal blooms die and start to decay, the resulting bacterial activity can reduce oxygen levels in the water body and lead to fish kills. Measuring the amount of algae in a water body is an indicator of ecological health. Chlorophyll is a measure used to determine the amount of algae in a water body.
