# WATERWAY AND CATCHMENT REPORT 2023

Reporting on data November 2022 to April 2023

MidCoast Council 2023 Waterway and Catchment Report Prepared by: MidCoast Council Natural Systems

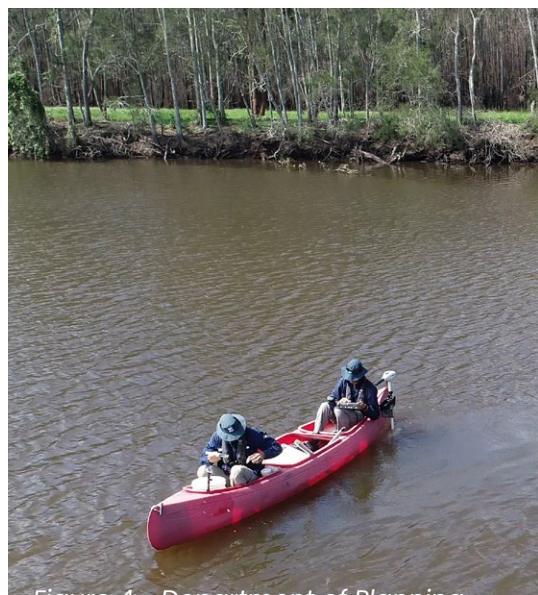
Figure 4: Department of Planning and Environment staff carry out monitoring of the waterways in the MidCoast Region

Samples were collected on six occasions between summer and autumn from November 2022 to April 2023. This represents the part of the year when the highest chlorophyll concentrations are expected.

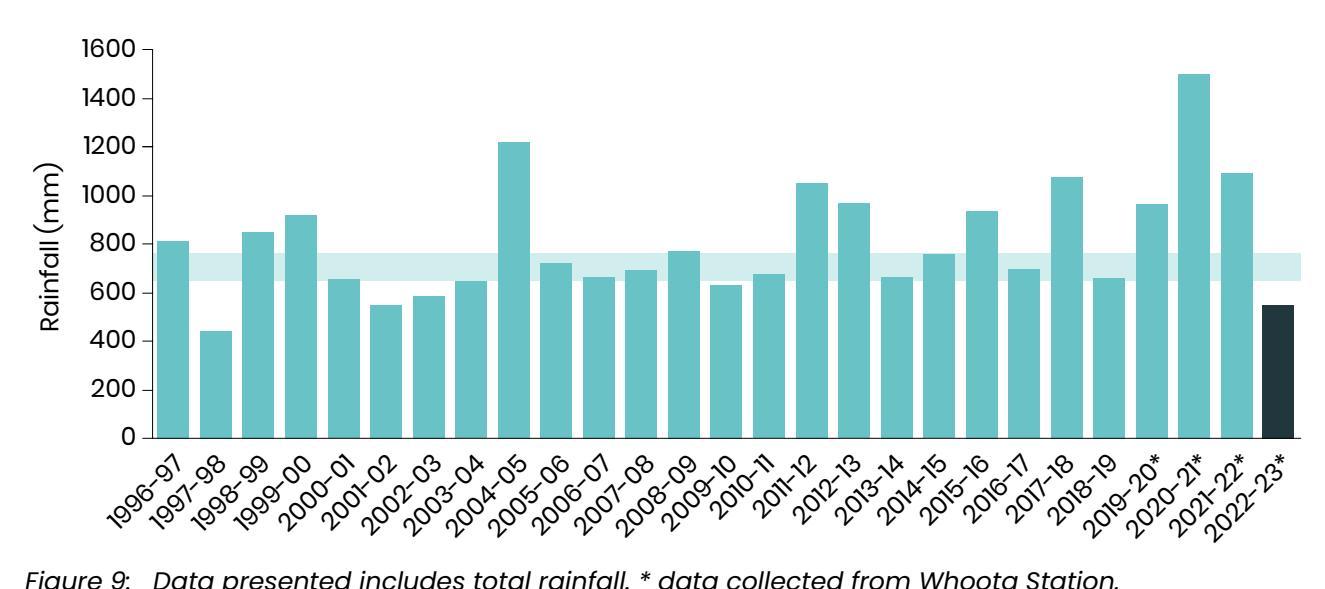
Figure 9: Data presented includes total rainfall. \* data collected from Whoota Station.

The rainfall data is taken from the Forster Bureau of Meteorology rainfall station (Tuncurry Marine Rescue and Whoota Station) (www.bom.gov. au/climate/data). Similar trends were seen in data throughout the MidCoast Area.

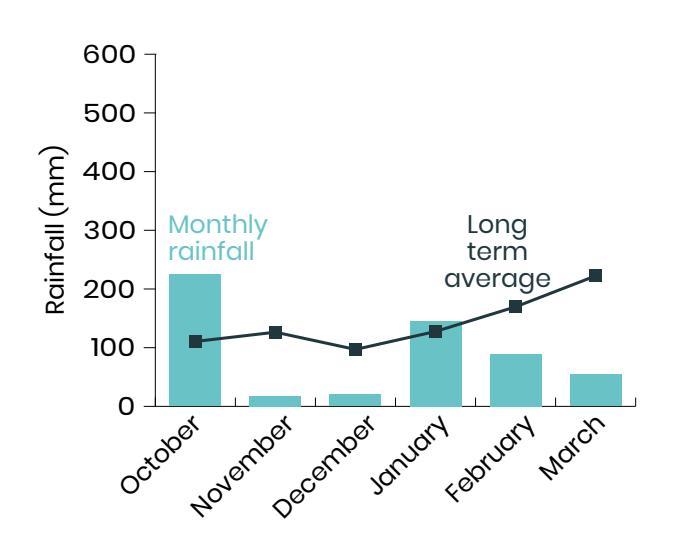
Figure 10: Monthly observed and long term average rainfall during the 2020-21 monitoring program at Whoota (bom.gov.au)

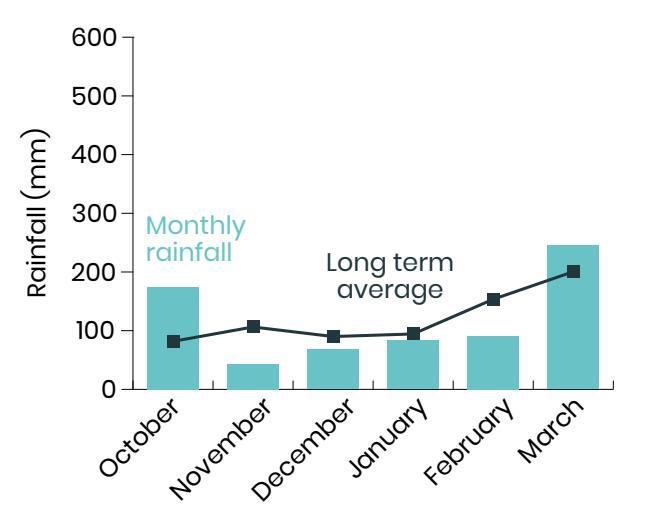
Figure 11: Monthly observed and long term average rainfall during the 2020-21 monitoring program at Taree Airport (bom.gov.au)

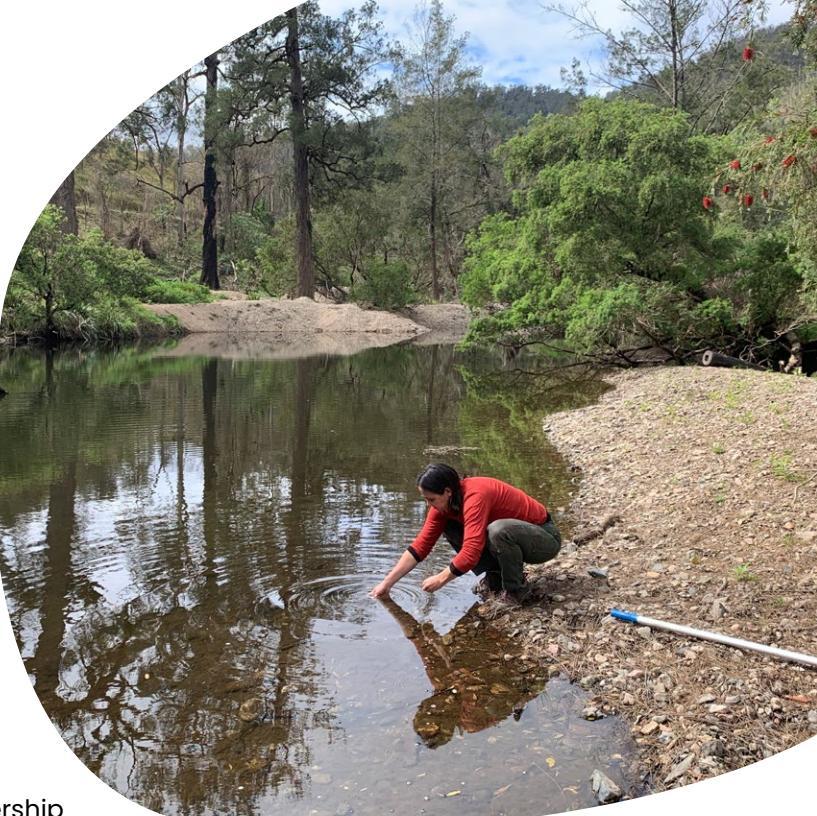
Figure 31: Water quality monitoring as part of the River Revival Project

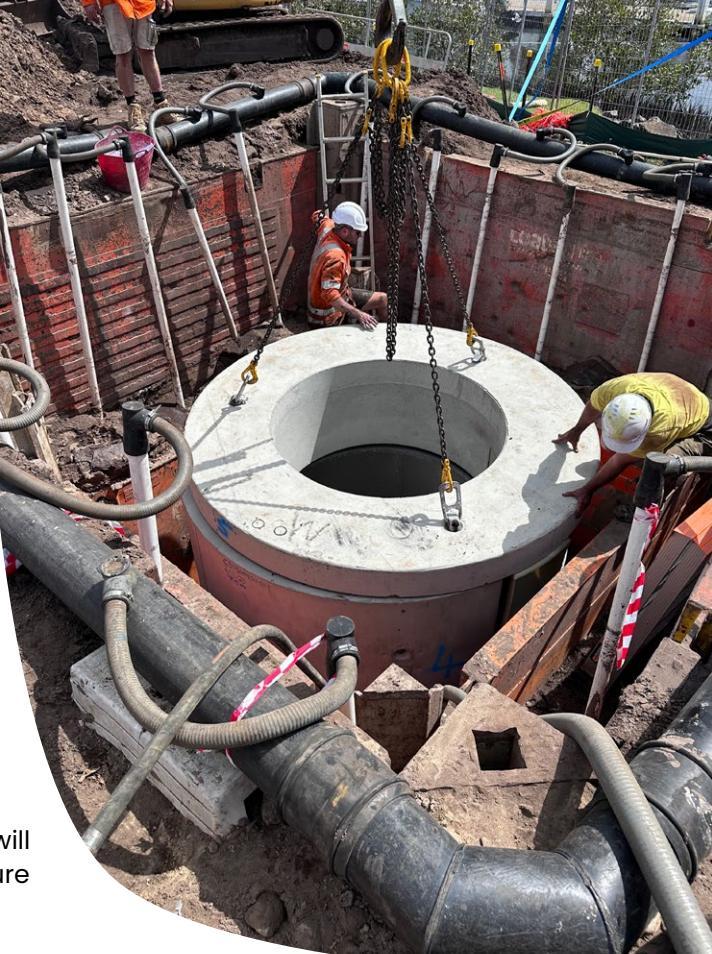
Figure 55: Installation of a new Gross Pollutant Trap in Forster will reduce the amount of pollution entering Wallis Lake.

Following an Aboriginal Heritage Assessment to ensure that the heritage of the area is protected and the upgrade to the GPT will not have an impact, works have commenced on the installation of the new device which will improvement containment of pollutants by 90% and ensure the protection of the lake for years to come.

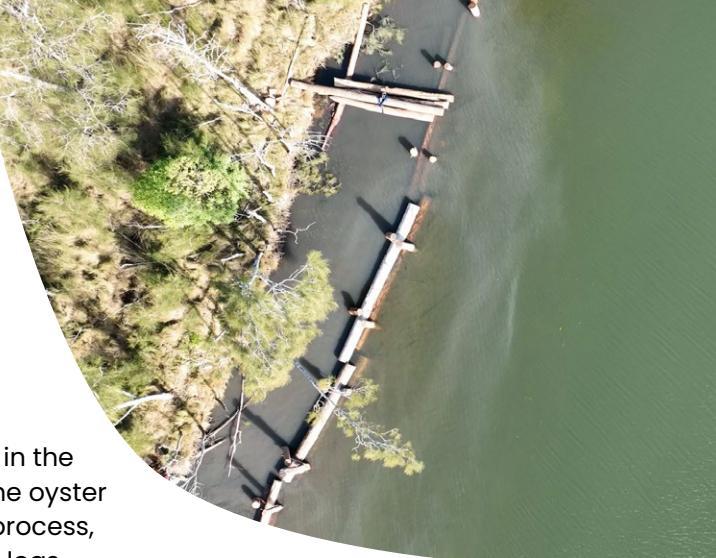
Figure 43: Timber being installed in the Wallamba River to protect the bank line and prevent erosion

In-water work has been focussed on Gereeba Island in the Wallamba River, Wallis Lake. Working together with the oyster industry to use discarded shell from the production process, LLS and Council are currently using a combination of logs, oysters and mangroves to stabilise eroding foreshore areas.
